# Manhole Inspection Summary

Manhole # S01EE2007MH

Insp Date: **7/20/06 10:34 AM**

**Location** Address: **6314 BENHURST RD**

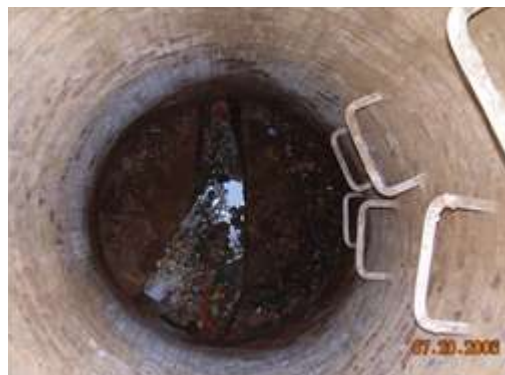
Top View

Adjustment and Barrel infiltration.  
evidence of surhcharge - Bench debris.  
Channel debris.

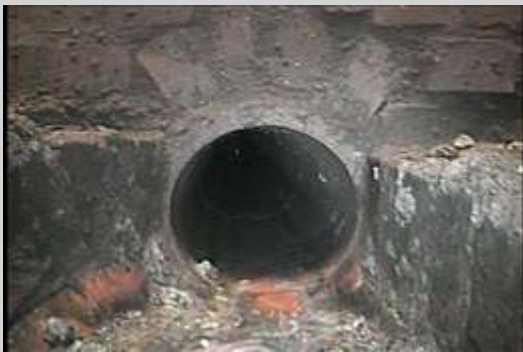
### 8 in. Circular Gravity Sewer Pipe Out @ 12 O'Clock

Invert Depth: **10.15** (ft.) Flow Characteristics: **Slow**

Deposits: ☐ None ☐ Mud ☐ Sludge ☒ **Debris** ☒ **Grease**

Silt Depth: **0** (in.) Deposits Extent: **Light**

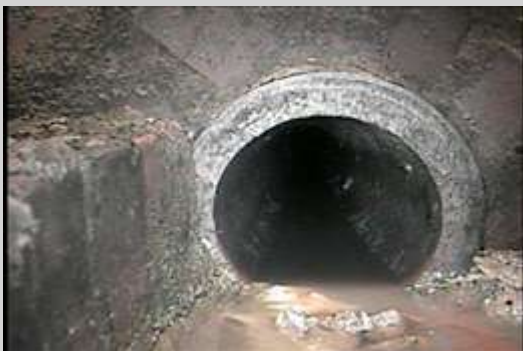
### 6 in. Circular Gravity Sewer Pipe In @ 7 O'Clock

Deposits: ☐ None ☐ Mud ☐ Sludge ☒ **Debris** ☐ **Grease**

Infiltration: **Evidence** Pipe Seal Cond: **Unknown**

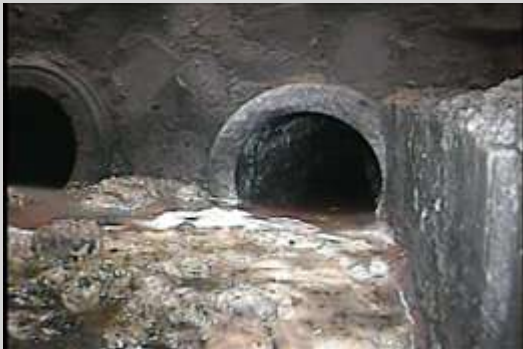
6 in. Circular Gravity Sewer  
Pipe In @ 8 O'Clock

Deposits: ☐ None ☐ Mud ☐ Sludge ☒ **Debris** ☒ **Grease**

Silt Depth: **1** (in.) Deposits Extent: **Light**
